Indiana Brownfields Conference Scribner Place

April 12, 2006

Presented by:
John Rosenbarger
New Albany Redevelopment &
Plan Commission Director

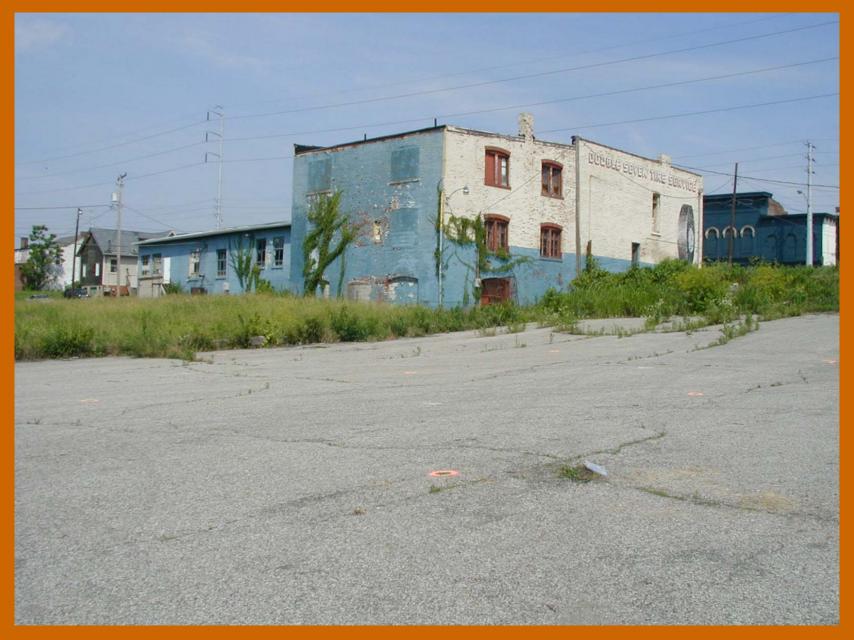
Scribner Place Site: 2005 Prior to Clean-up

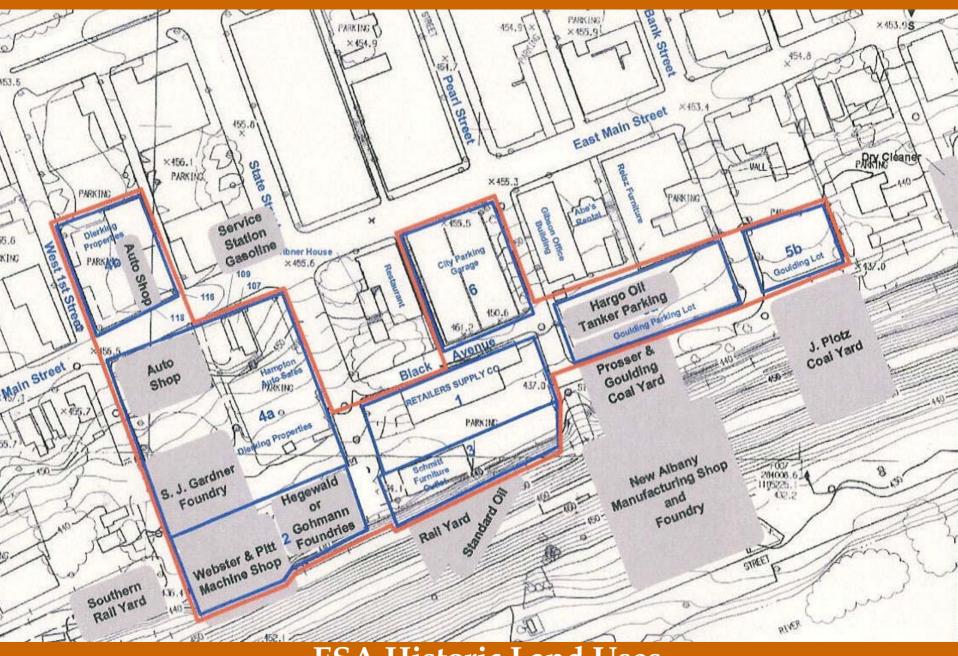
ESA Historic Land Uses
